Technical Bulletin

Subject: Eliminating wind noises

Models(s): Passat 1995 m.y.

Number: 94-01

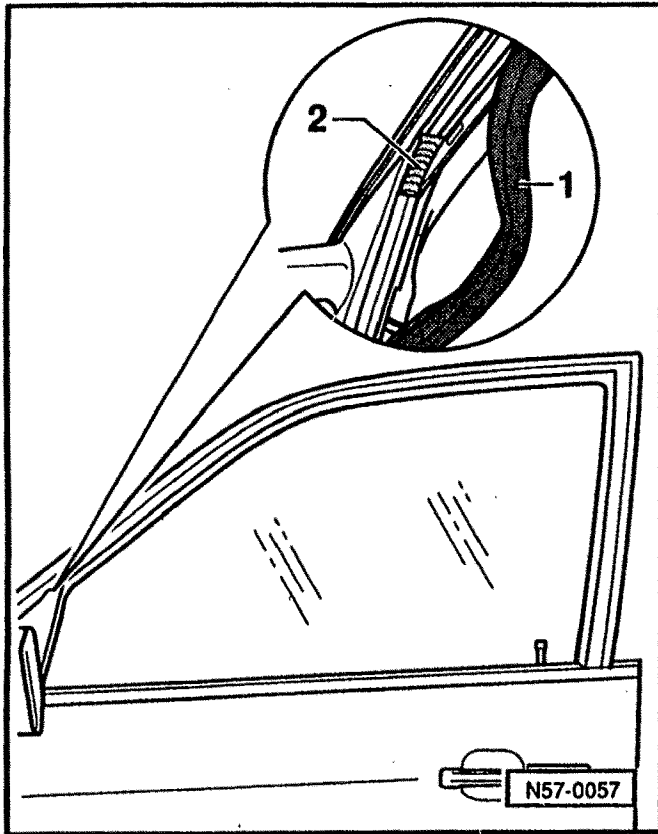
Front doors at A-pillar

Resonance can occur at the outer/lower window guide vulcanization point.

- Pull off cover in front corner of door frame.
- Pull off inner window guide -1-.
- Apply felt strip -2- (size 40 x 10 x 3 mm)
Part No. 533 863 288 A, to area indicated.

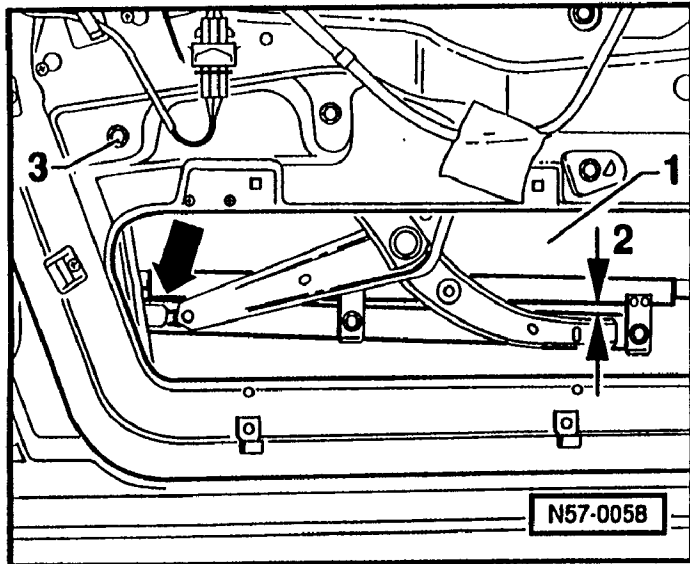
Front doors with power windows

When the door windows are lowered, the door outer panel is pushed outward or the window slot seal is lifted up. The result is a roaring noise at the window slot.

Check the setting of the door window and adjust if necessary.

- Remove door trim panel and vapor barrier.
- Front of window -1- must be raised 2.0 mm from window regulator -2- and sit properly at the rear (arrow)
- Rear securing point -3- of lower guide rail must be set downward to the stop.
- Window must be aligned parallel to window guide.

The window must not be tilted forward as it could then become derailed from the window guide.

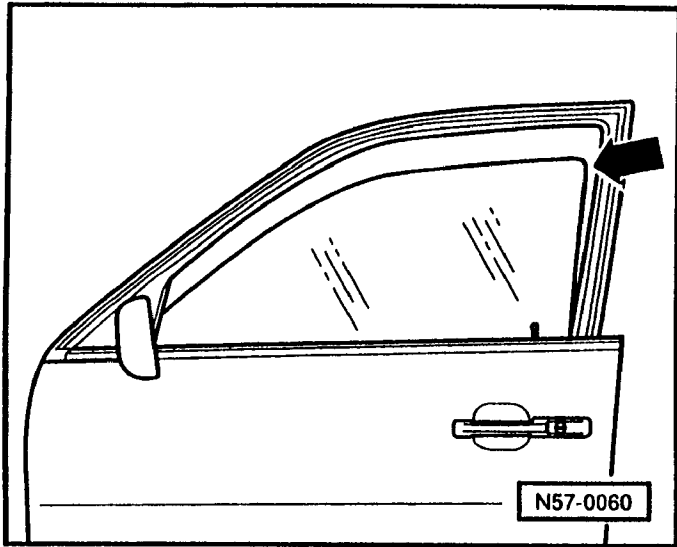
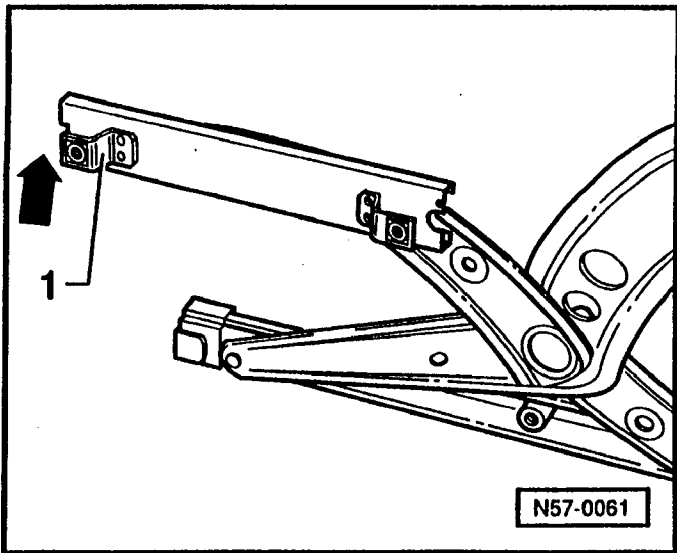
Front doors at B-pillars

The window is tilted forward resulting in an insufficient seal to the outer window guide at the B-pillar (arrow).

- Check setting of window as described under "Front doors with power windows" on page 50–2. Adjust window as necessary.
- If window cannot be adjusted as described, remove window regulator.

- Bend rear securing point -1- of the lower guide rail up about 1.0 mm.
- Reinstall window regulator and adjust window as necessary.

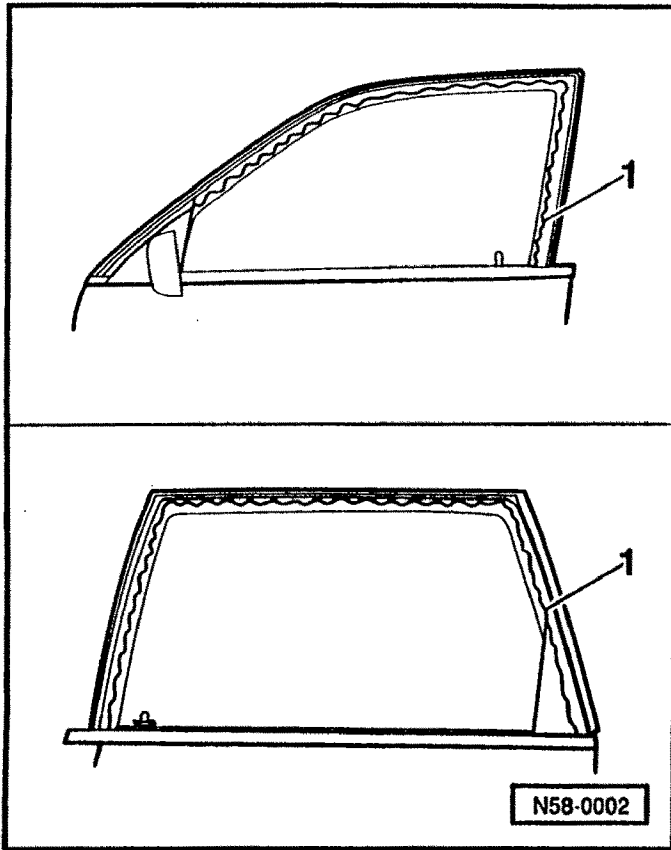
Doors – warped window guides

Loud airflow and resonance noises, especially at the B and C-pillars.

- Replace window guides -1-.

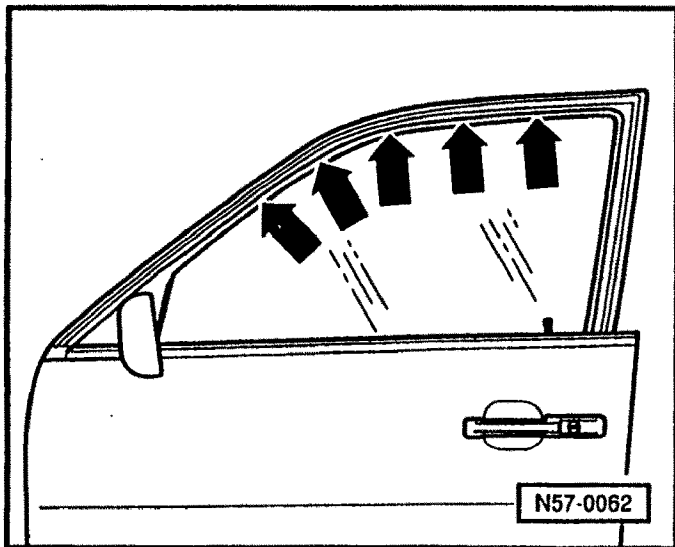
Doors – window guides not opened out

Window guides that are not sufficiently opened out can transmit noises due to gaps (arrows) between window and guide.

- Open out window guides evenly.

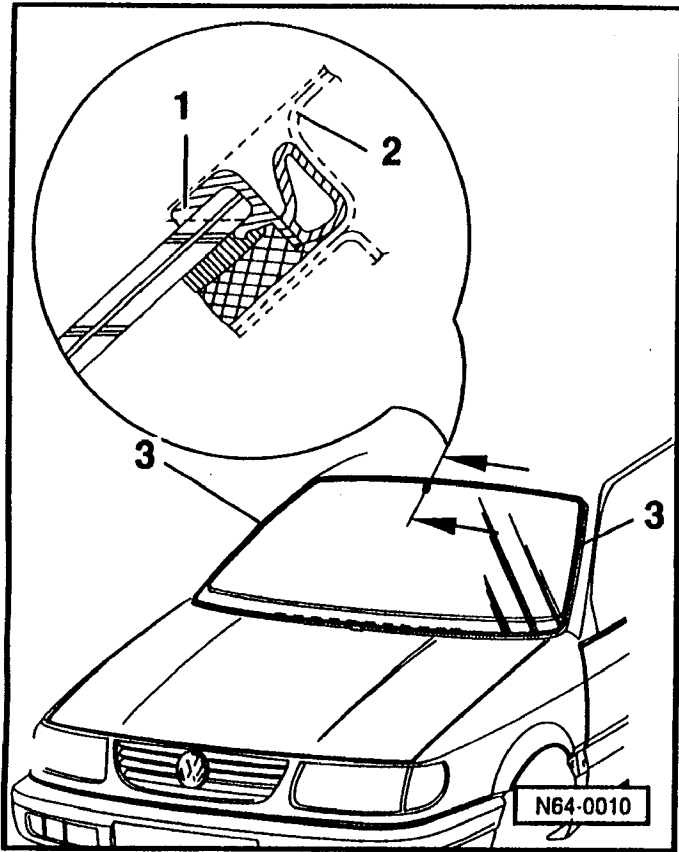
Windshield – too high in opening

A windshield placed too high in the opening can cause loud airflow noises.

- Remove windshield.
- Install windshield and press in until frame -1- is flush with roof -2- and A-pillars -3-.

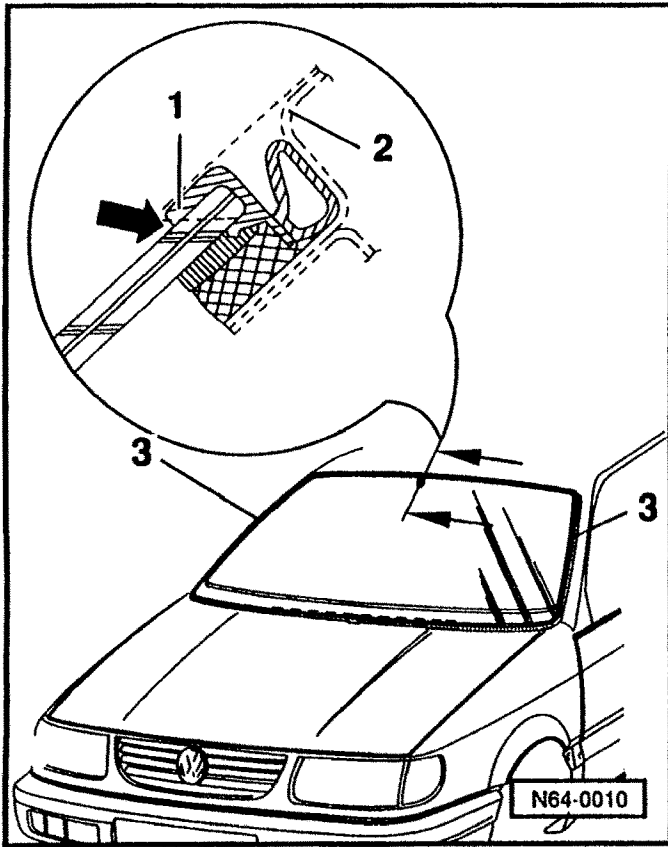
Windshield – gap between glass and frame

Loud roaring noises are produced if the windshield frame -1- is not evenly seated on the windshield glass.

- Seal gap (arrow) with sealant, Part No. D 001 007 or equivalent.

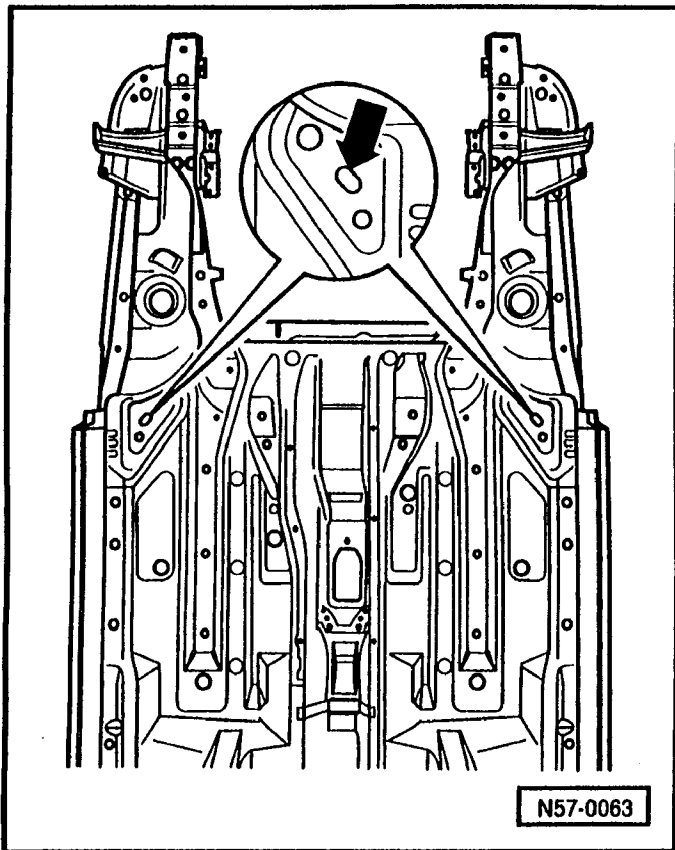
"Howling" wind noise

These noises start at approx. 50 mph (80 km/h) and are presumed to be coming from the area behind the rear doors.

- Replace missing oval plugs (arrow) in floor panel.
Part No. N 904 028 01.
